BUILDERS & FLYERS GP4 NEWSLETTER

MAY - JUNE 1997

BILL BERRICK OF OMAHA, NEBRASKA MAKES HIS FIRST FLIGHT IN HIS GP-4!

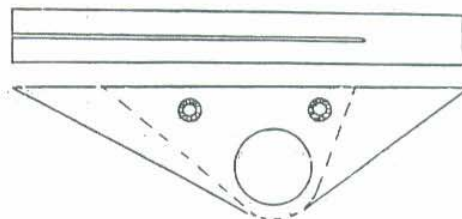
NYLON TAIL SKID

I also added another 2 oz. by making a tail skid out of 3/4" nylon to fit over the sheet metal tie down point on the tail truss, (see drawing). It fits against the tail cone and is retained by two 10-32 machine screws. The tie down point is less than two feet off of the runway at

neip when I am being sure to touch down on the mains rather than the nose wheel.

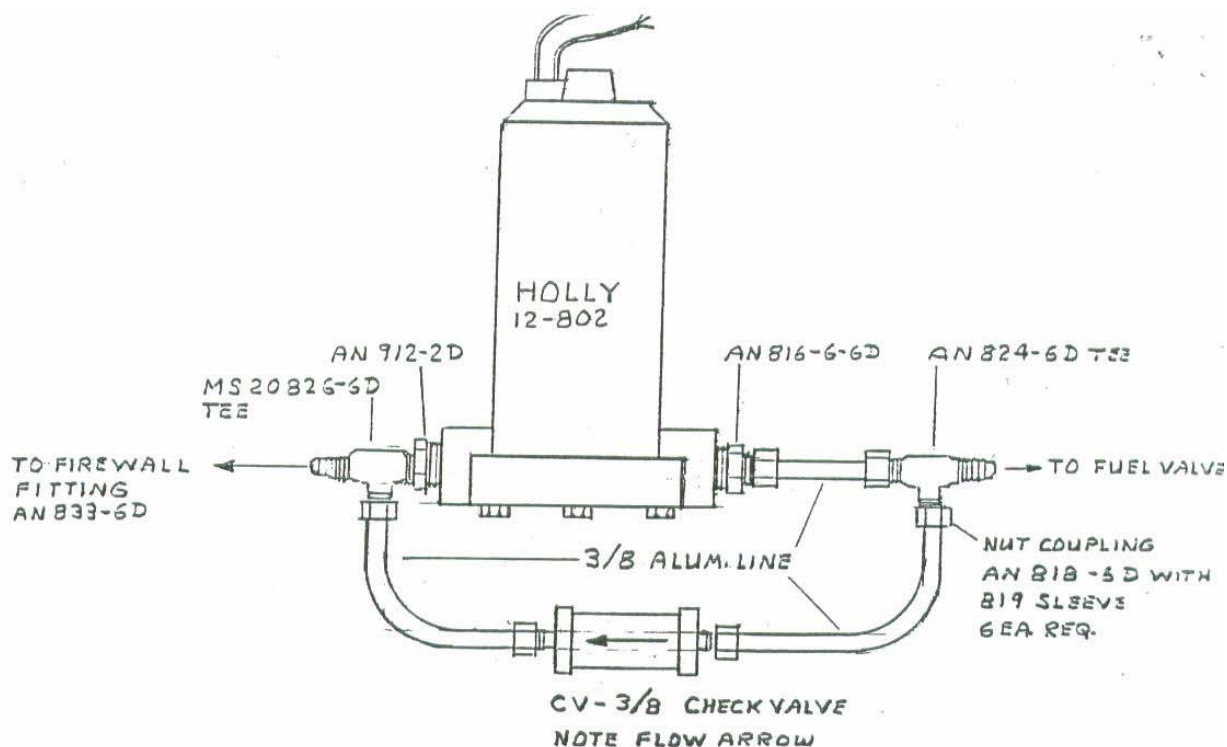
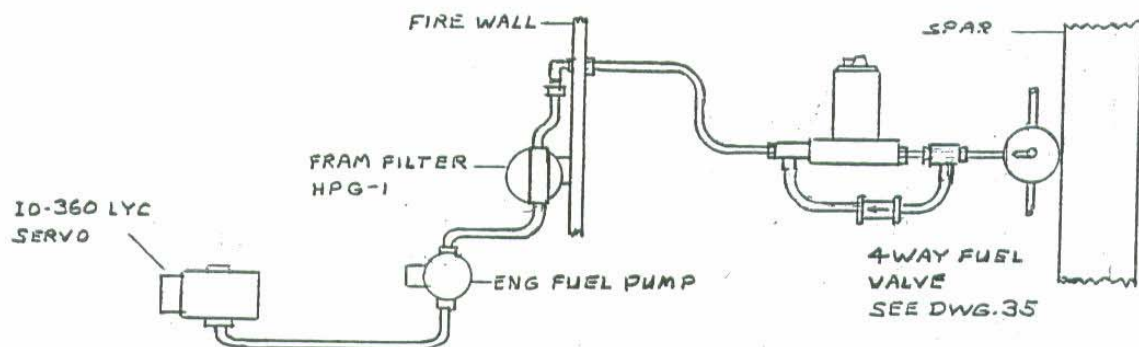
"More on Aux. Pumps"

THE HOLLY 12-802 HAS A MOUNTING BRACKET NOT SHOWN HERE. IT CAN MOUNT HORIZONTAL UNDER THE PILOT'S SIDE FLOOR IN FRONT OF THE FUEL VALVE. AN ACCESS PANEL IN THE BOTTOM SKIN MUST BE INSTALLED. IT SHOULD BE A FLUSH FIT ABOUT 6" WIDE X 9" LONG. LARGE ENOUGH FOR PUMP REMOVAL. THE HOLLY 12-802 REQUIRES A SMALL SPRING INSTALLED TO RAISE FUEL PRESSURE TO 19 PSI. ASK FOR THIS SPRING WHEN PURCHASING PUMP FROM AUTO SPEED SHOP.
