GP4BFN53

News for builders of fast wooden aircraft!

GP-4

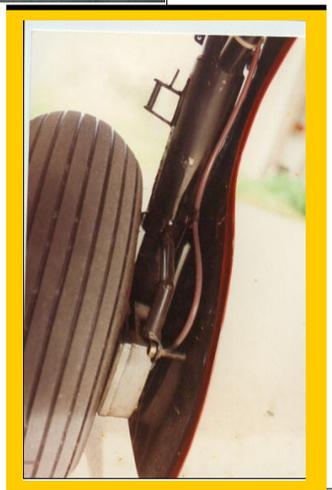
The prototype GP-4 uses a manual landing gear retraction system. After numerous repeated requests from builders, George developed an electric hydraulic gear for the GP-4.

No machine work is required for any of the components. Plans are available for \$150 from Osprey Aircraft. You can find the address and an order form on the website and on the last page of this newsletter.

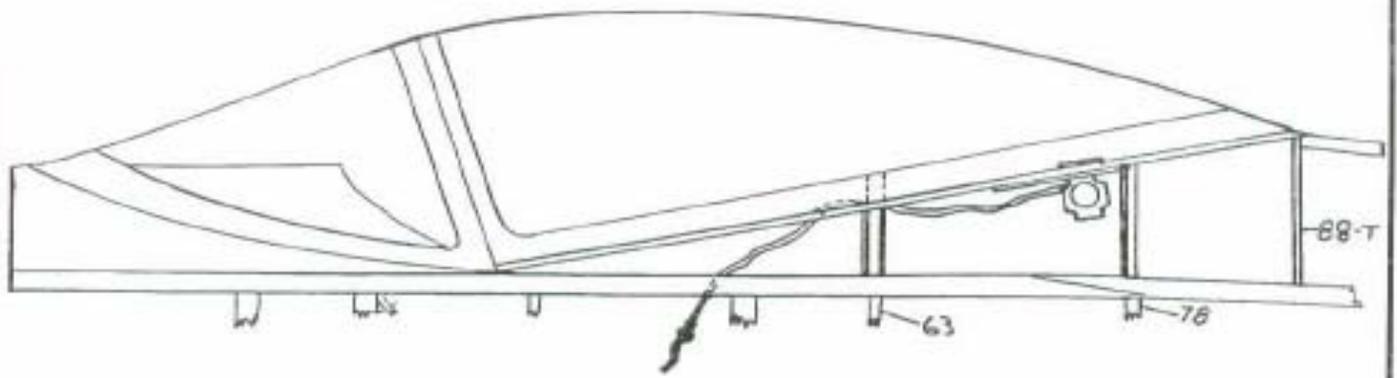
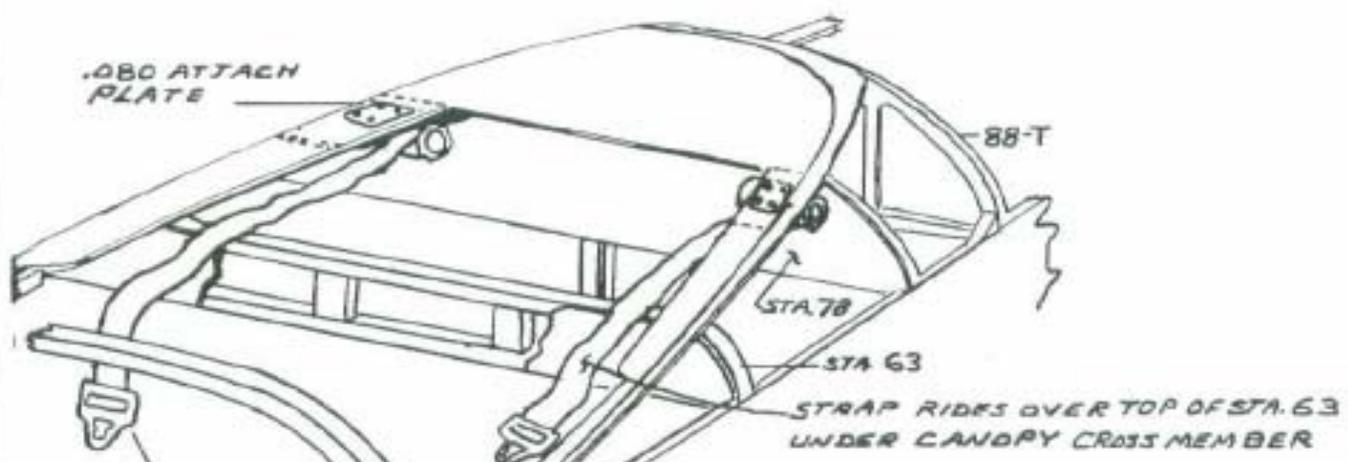
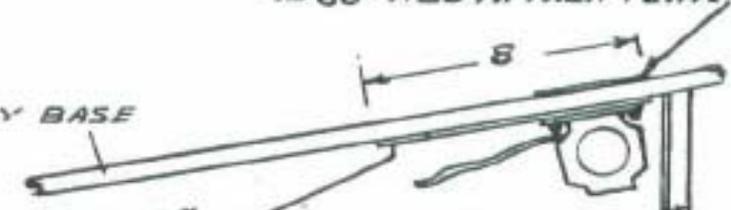
INERTIA REEL
INSTALLATION
NO SCALE
DESIGN: OSAREY AIRCRAFT
REEL (HONDA) USED.

TYPICAL METAL STRAP FITTING BUCKLE SLIPS OVER KNOB ON SEAT BELT BUCKLE

080 4130 ATTACH PLATE

4 EA. 1032 FLUSH MACHINE SCREWS REQ. EA. SIDE

SEWING PATTERN TO JOIN STRAPS

Back in 2001 I answered a builder about seat belt and shoulder harness installation. At that time the hydraulic gear was not available, which caused a problem with a fixed shoulder harness. The harness, if fixed, would not allow the pilot to lean forward in order to easily unlatch the landing gear lever and retract the gear. I solved the problem in the prototype by using automotive inertia reels. Two Honda reels were mounted on the aft side of the canopy base on each side. One reel for pilot and one for passenger. I used only a single strap

over the shoulder into the metal to metal seat belt attachment buckle. My 1 7/8" seat belts were new aircraft grade, with

provision for a metal attachment of a shoulder harness. Both spruce and Wicks have these available.

The Honda reels had black straps which I pulled out of the reel, and machine sewed the matching shoulder belt to the Honda strap. This sewn section was then reeled back into the reel and does not show. Not having a sewing machine, I had a shoe shop do the job for me. You may have to drill new mount holes into the reel base to mount the 1 1/2" ply canopy base. The base should be re-inforced as shown in my drawing. The seat belts are easily bolted into the aft end of the four seat rails. Some of you may want to use an adjustable shoulder harness—rather than the inertia reel if you have the hydraulic gear.

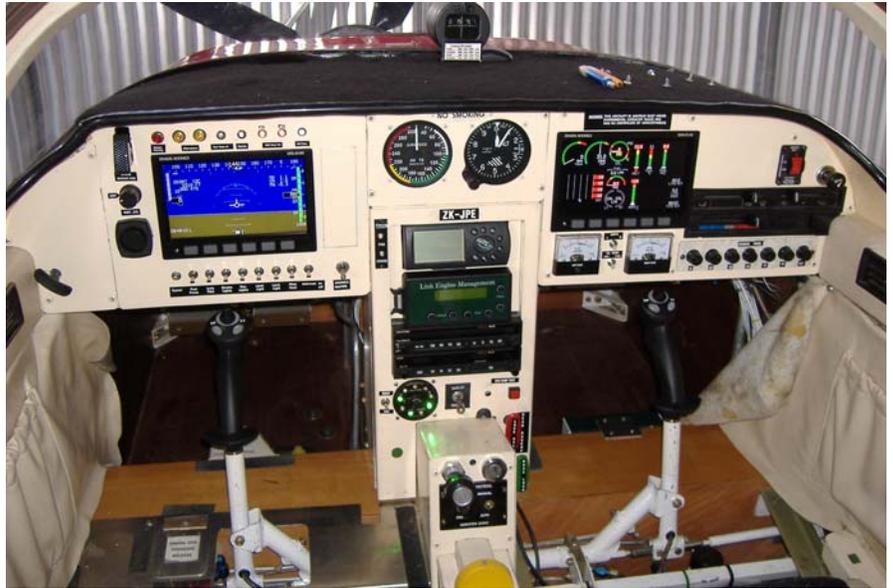
For the second time I found the nosewheel steering limit plate on the leg cracked at the weld. In my view this needs beefing up a little and you will see in the photo what I have done. You will see that mine is on the front of the leg not the back as shown in the plan, don’t know how that happened!!

The other picture shows the new panel.

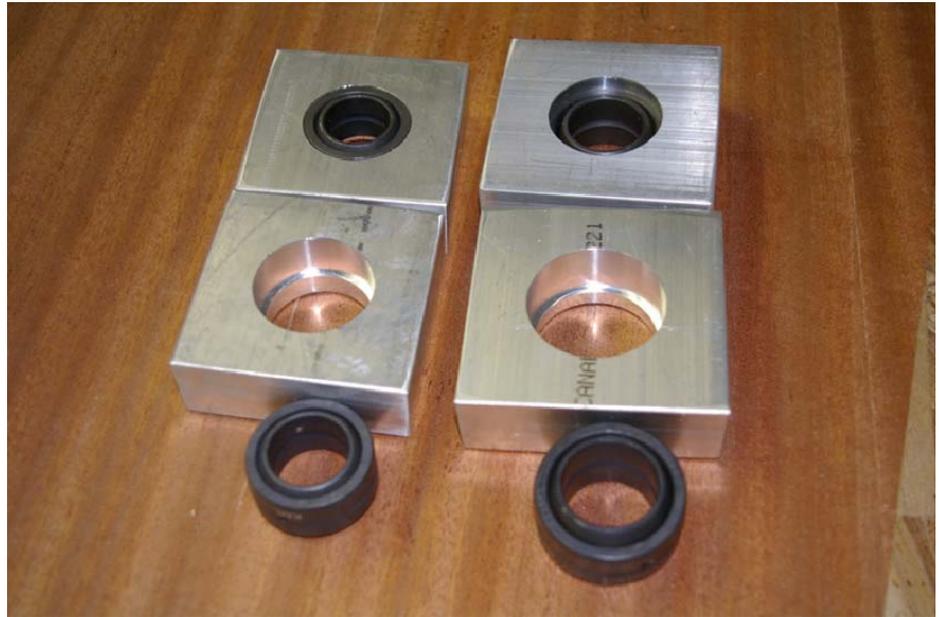
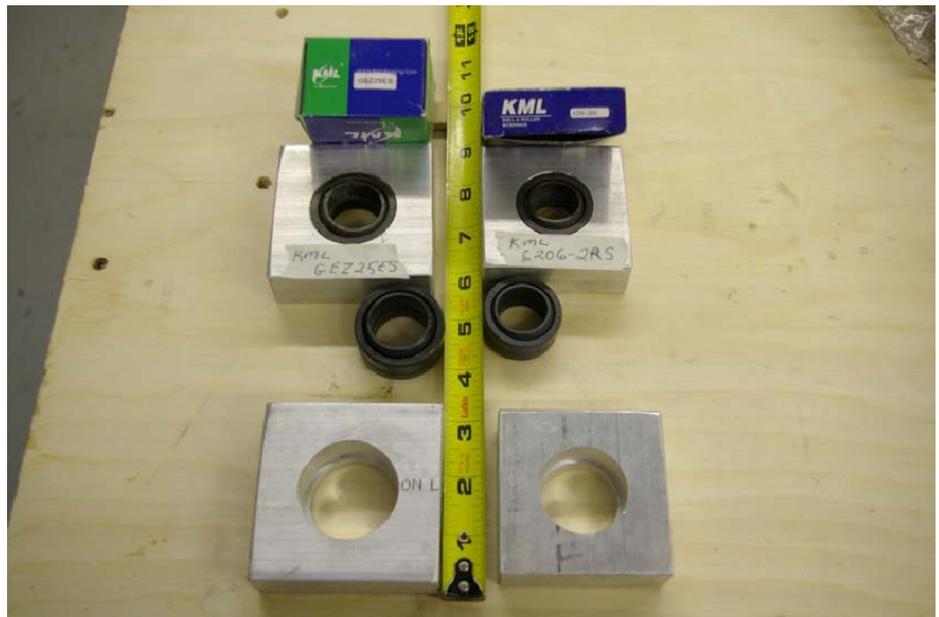
MAIN GEAR TRUNION BEARINGS

The main gear strut and link arm trunions are attached to the front spar with aluminum blocks drilled at an angle of 82 degrees and to the rear spar with aluminum blocks drilled at an angle of 86 degrees. The holes are one inch in diameter for the main gear trunion and 7/8 inch for the link arm trunion. This system works quite well but alignment must be precise to avoid the trunion arms binding in the bearing blocks. This system does have a problem in that even when well greased it is metal to metal and when pressure is applied to the gear in the form of air loads it will cause the system to move with more resistance as pressure increases. A lack of grease in this area would compound the problem. Wayne Tomkins, Australia and I visited Ernie Holmes, Orange, Mass. two summers ago and during the discussions on gear fabrication, Ernie suggested an eyeball type of bearing and showed us an example. Further investigation by Wayne and I located a suitable bearing sold by KML that seem ideally suited to our needs. The bearing numbers are KML GEZ25ES and KML 6206-2RS and retail for just under \$10.00 each. These bearings have a groove completely around the outer case which makes an ideal grease path when a grease fitting is installed in the aluminum carrier block. The bearings pivot sufficiently in all directions to allow for a wide range of installation angles. We had our bearing blocks drilled at exactly 90 degrees and left a shoulder (or seat) on the inner portion of the hole to seat the bearing in place. A small collar is welded around the trunion arms which bear against the center portion of the bearing and prevents the trunion from moving forward or back. Wayne has completed fabrication and installation of his main gear including hydraulic and

electrical systems and using the KML bearings. He reports the system was not difficult to align and works very smoothly with no obvious friction problems. The gear photos with this article are clearly indicative of Wayne's outstanding workmanship. This system should

fail the trunion should remain functional. Bearing replacement would be simple compared to milling a new bearing block at the correct angle. I have discussed this design change with George and he indicated he could not see any reason the bearing system could not be

also greatly enhance the ability of the gear to free fall into a locked down position should the hydraulic or electrical system fail. Normal maintenance should give years of service and in the event a bearing
